BAYSHORE REGIONAL SEWERAGE AUTHORITY REHABILITATION OF EXISTING SLUDGE CONCENTRATION TANKS PROJECT

Richard Crane, P.E., BCEE Senior Director- Water Resources-PS&S Thomas Petti, P.E., CME, Principal Engineer Bayshore Regional Sewerage Authority

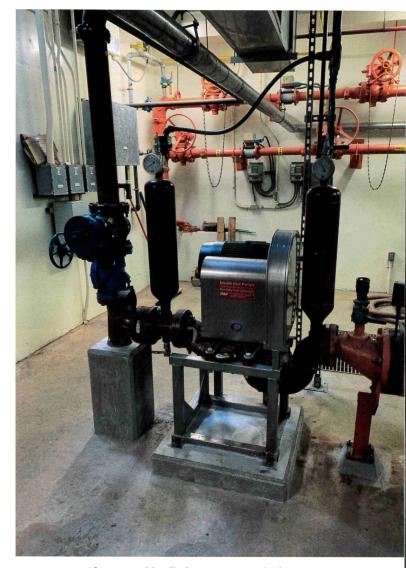
The new positive displacement pumps in the Primary Sludge Pumping Station #2.
